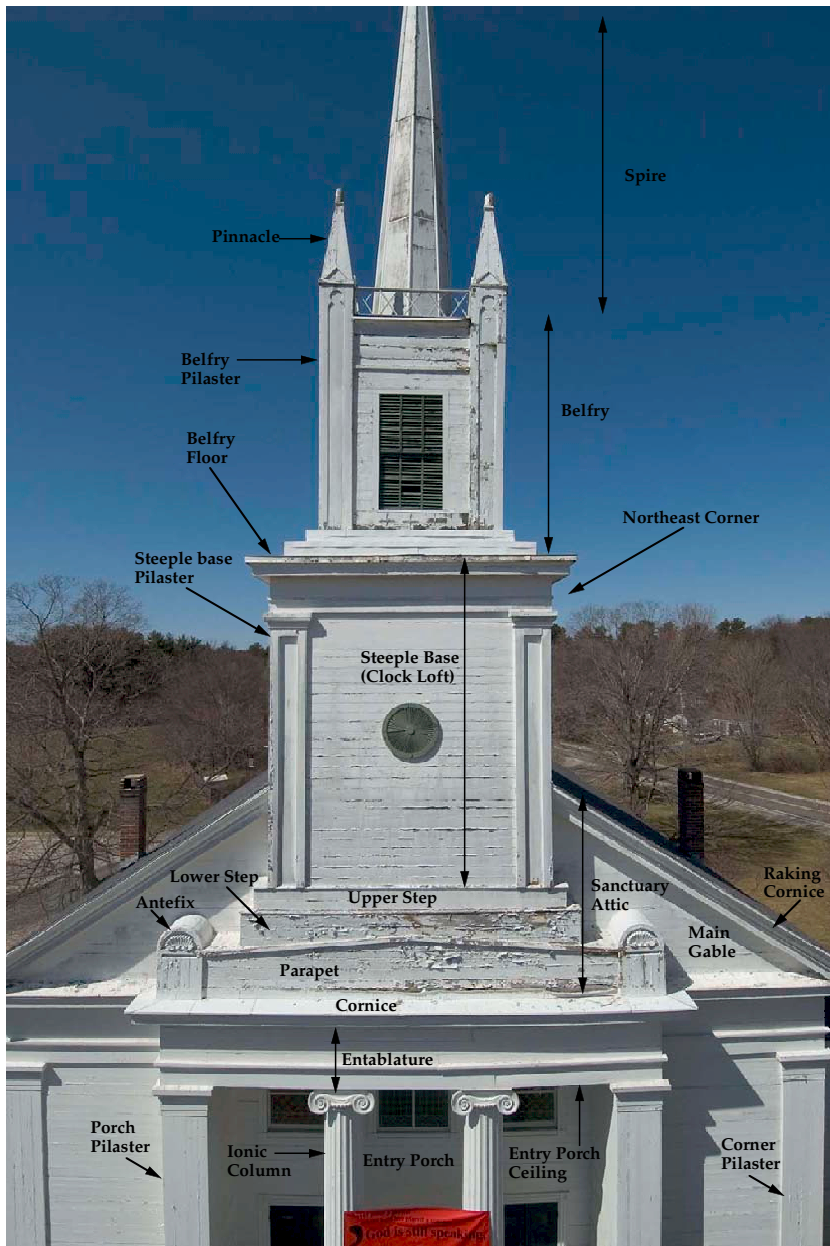
3.1: Front (east) facade with names of architectural features.

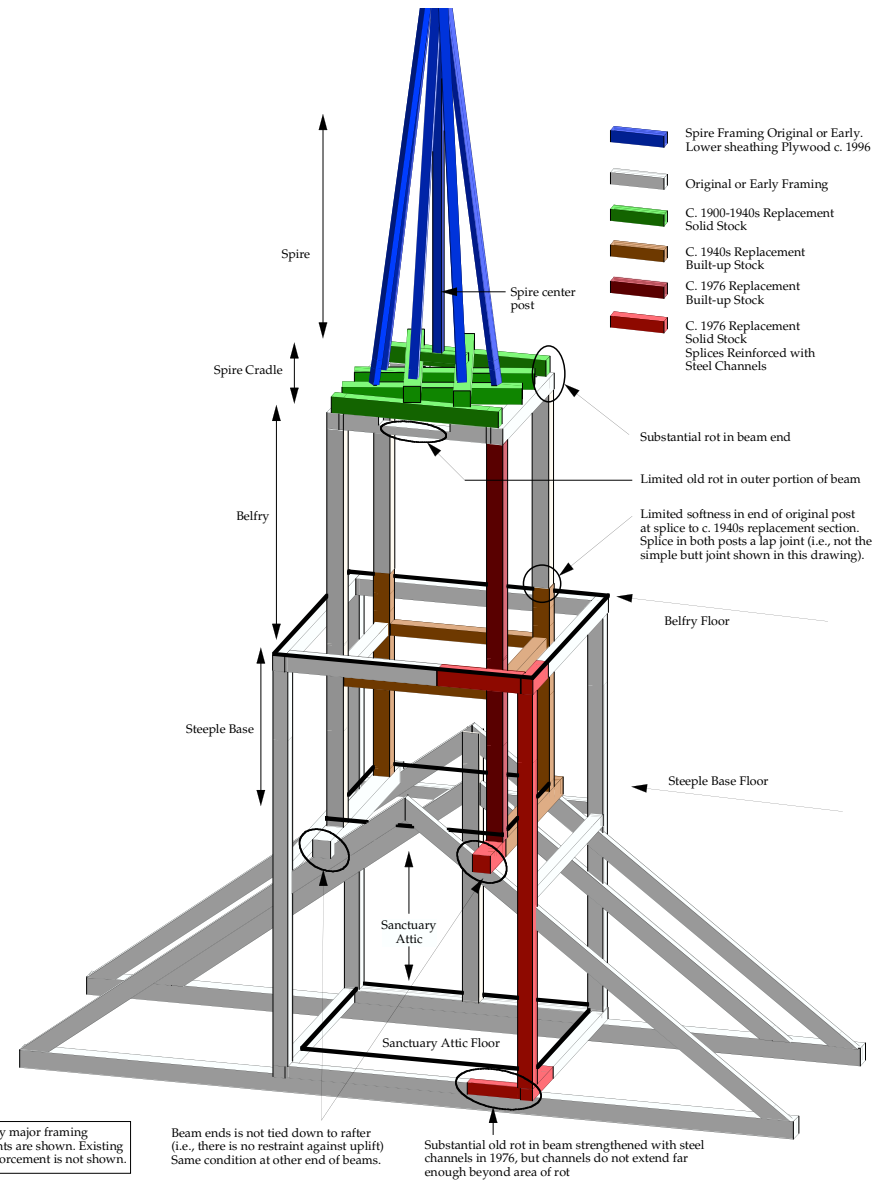
3.2: Three dimensional drawing of principal steeple framing as viewed from front with primary structural issues noted. Age of various past replacement timbers is indicated by colors.
